## REINFORCING THE CARBURETOR AIR DUCT AND OTHER MUSTANG MODIFICATIONS FROM THE 24 JULY 1943 ISSUE OF NAA WEEKLY SERVICE NEWS

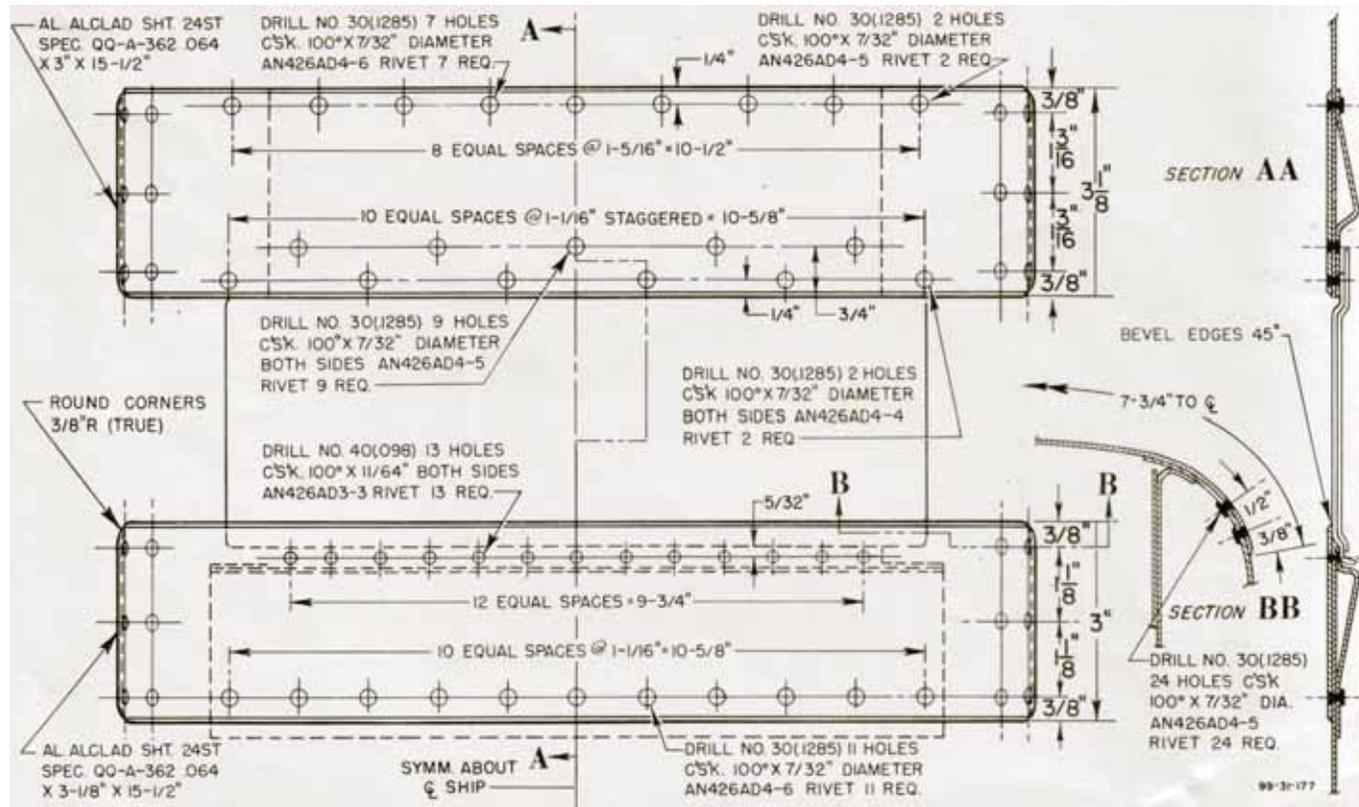
FIGURE 1: Illustration of how the strengthening modification would be undertaken.

A corrective measure has been undertaken by Engineering to prevent engine backfires from damaging the air filter door on the P-51A series. This is accomplished by two 24ST Alclad (.64) strips forward and aft of the air duct door as shown in FIGURE 2. These reinforcement strips have been tested under normal conditions at the factory and proved satisfactory.

Layout of the two 24ST Alclad (.64) reinforcement strips is shown in FIGURE 1.

When the strips are cut and drilled they will serve as templates when drilling the holes in the cowling skin. A few holes will have to be countersunk on the underside of the skin.

"C" clamps are used to hold the strips tightly against the skin, binding them to fit the contour of the cowling.

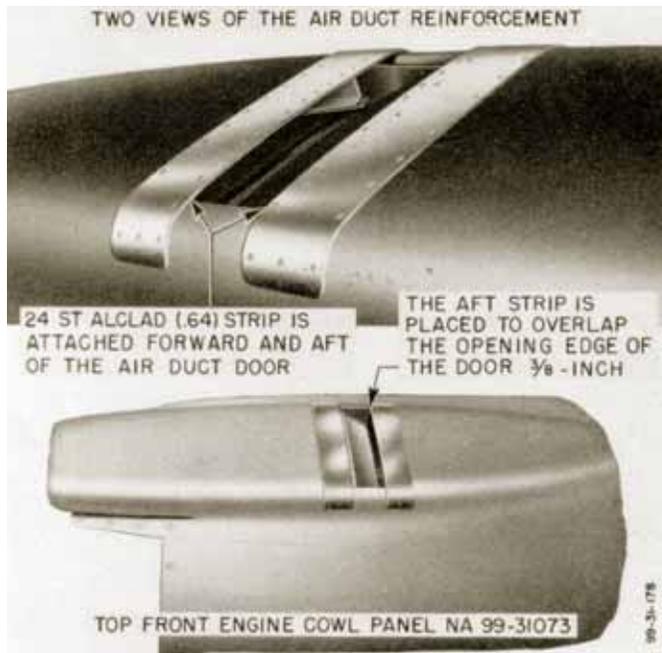
FIGURE 2: The reinforcement strips would prevent the panel from possibly blowing off as a result of a backfire.

The forward strip is placed along the edge of the hinge in the air

duct door. The aft strip is placed to overlap the opening edge of the door 3/8th-inch (FIGURE 2).

The strips are centered in line with the center of the air duct door

and when in this correct position they are first riveted at the two outboard center holes on the edge. This will hold them so that the balance of the riveting may be done properly.

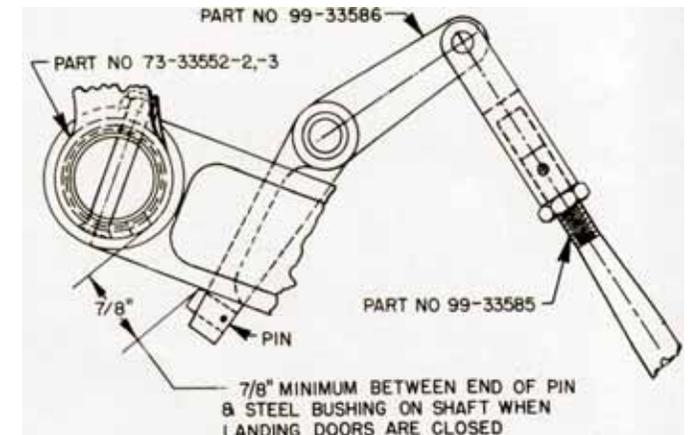
To prevent bending and shearing of the pin in the bellcrank (NA 99-33586) on P-51A, P-51B, and P-51C pursuits, as has been reported from the field, Engineering recommends the following action be taken.

The doors are deflected by the air loads during flight, thereby allowing bellcrank (NA 99-33586) to lock the landing gear controls when pin engages hole in tube assemblies (NA 73-33552-2-3). This condition can be prevented by maintaining a distance of 7/8th-in minimum between tube and pin when doors are closed.

FIGURE 4: The bellcrank rework.

Pilots of the above type airplanes should be cautioned that a full operating sequence to DOWN position must be completed before attempting to reposition the control. The purpose of the pin is to lock

Inspection and necessary adjustments should be made to provide a 7/8th-in minimum clearance between the end of the pin and the steel bushing on the shaft when the landing gear doors are closed (FIGURE 4).
