TESTED TO DESTRUCTION

BEFORE BEING RELEASED FOR SQUADRON USE, NORTH AMERICAN ENGINEERS BRUTALLY TESTED MUSTANG COMPONENTS TO MAKE SURE THEY COULD STAND UP TO THE RIGORS OF AERIAL COMBAT

BY HOWARD CARTER

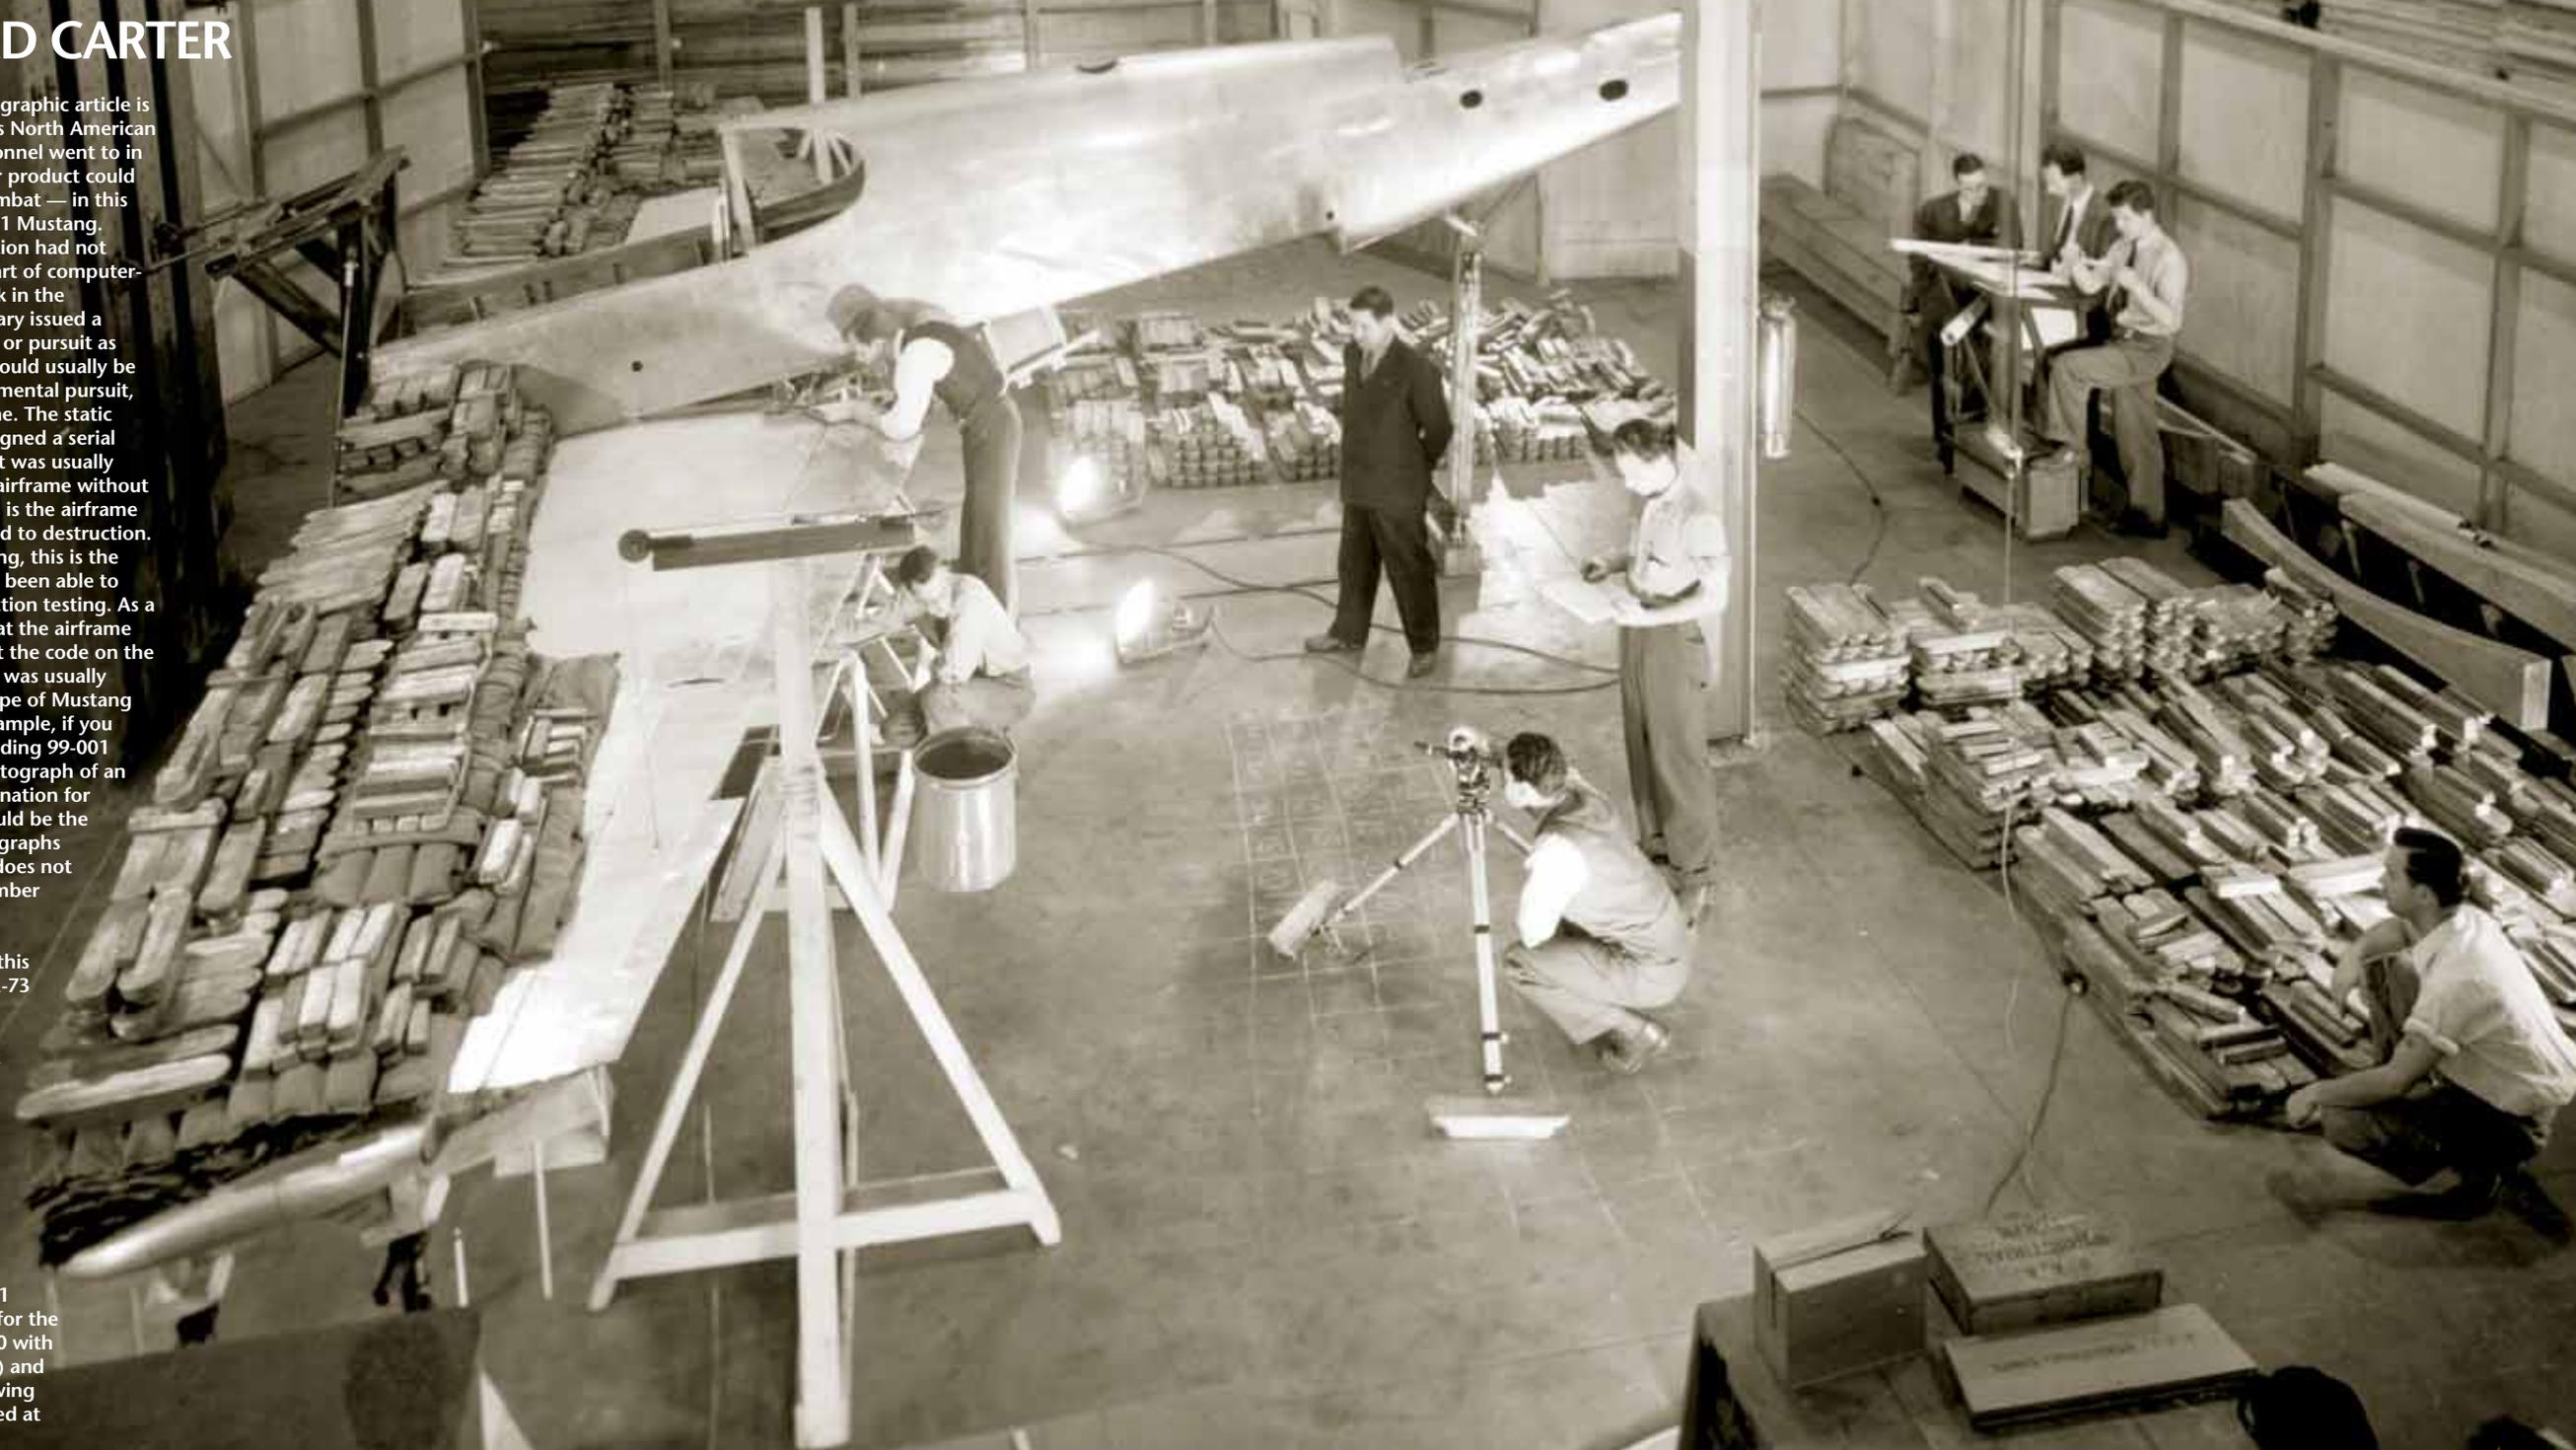
The main point of this photographic article is to illustrate the great lengths North American Aviation engineers and personnel went to in order to make sure that their product could face the harsh realities of combat — in this case the product was the P-51 Mustang. Structural testing to destruction had not developed into today's fine art of computer-controlled static testing. Back in the 1930s/1940s, when the military issued a contract for a new fighter — or pursuit as they were then called — it would usually be for two XP airframes (experimental pursuit, flying) and one static airframe. The static airframe would rarely be assigned a serial number or designation and it was usually incomplete — just the basic airframe without electrics, hydraulics, etc. This is the airframe that would be statically tested to destruction. When it comes to the Mustang, this is the earliest photograph we have been able to find relating to static destruction testing. As a point of interest, it seems that the airframe was referred to as XX-73, but the code on the negative is "81." This coding was usually reserved for the particular type of Mustang being photographed. For example, if you found a negative with the coding 99-001 this would translate to a photograph of an NA-99, the NAA model designation for the P-51A while the -001 would be the sequence in the set of photographs being taken. The coding 81 does not relate to any NAA model number and may be an in-house designation for photographs concerning static testing. In this photograph, we have the XX-73 wing and fuselage with the wing being heavily loaded with lead ingots. The aircraft has been surrounded with a relatively crude plywood "wall." This was put in place in case the airframe violently came apart under extreme load — pieces of aircraft could fly some distance, injuring personnel and property. The photograph was taken on 16 January 1941 (the NA-73X had gone aloft for the first time on 26 October 1940 with Vance Breese at the controls) and illustrates a crucial point — wing strength trials. The wing failed at 105% of its design load.
