## REINFORCING THE CARBURETOR AIR DUCT AND OTHER MUSTANG MODIFICATIONS FROM THE 24 JULY 1943 ISSUE OF NAA WEEKLY SERVICE NEWS

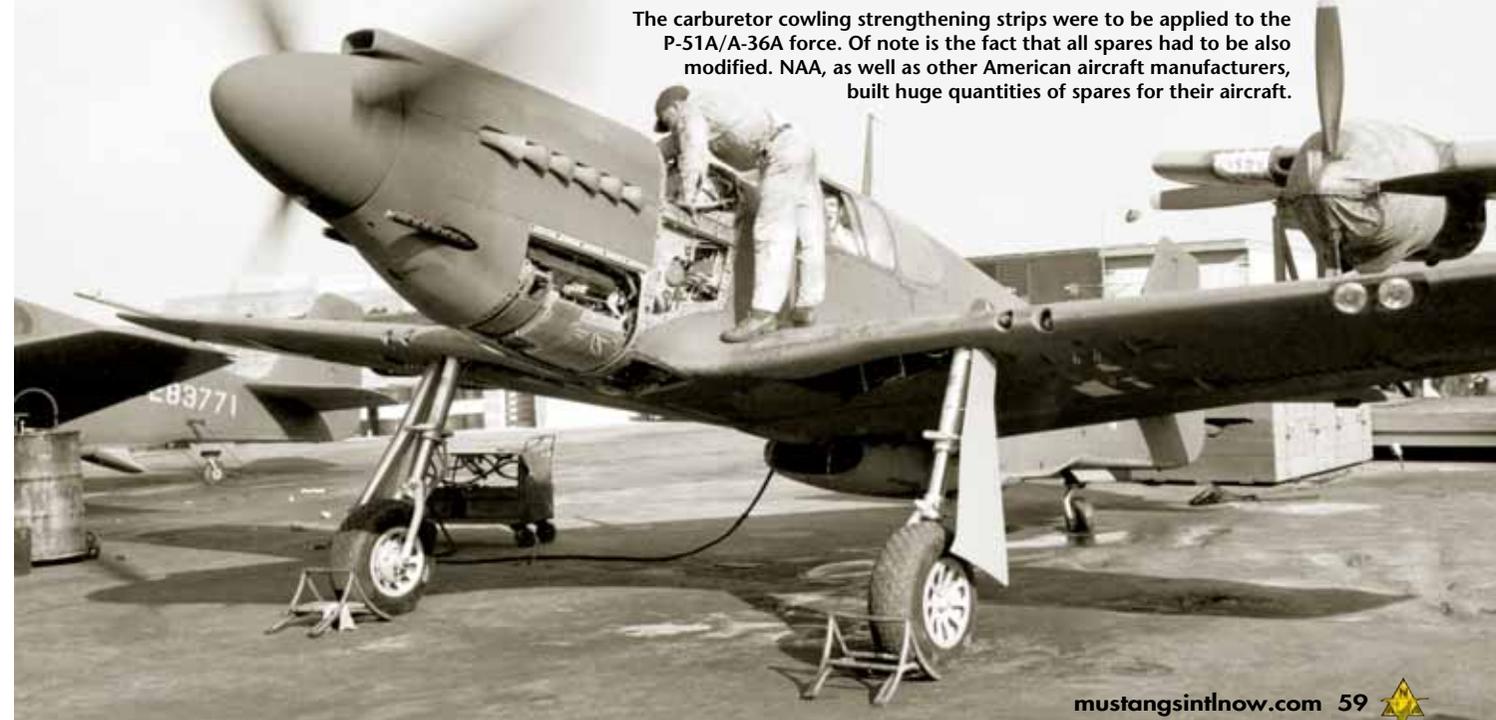
The carburetor cowling strengthening strips were to be applied to the P-51A/A-36A force. Of note is the fact that all spares had to be also modified. NAA, as well as other American aircraft manufacturers, built huge quantities of spares for their aircraft.
